**Review of Responses to  
NRC Bulletin 2003-02-Leakage  
from Reactor Pressure Vessel  
Lower Head Penetrations and  
Reactor Coolant Pressure  
Boundary Integrity**

Prepared by  
E. Sullivan and G. Cheruvenki

**Division of Component Integrity  
Office of Nuclear Reactor Regulation  
U.S. Nuclear Regulatory Commission  
Washington, DC 20555-0001**

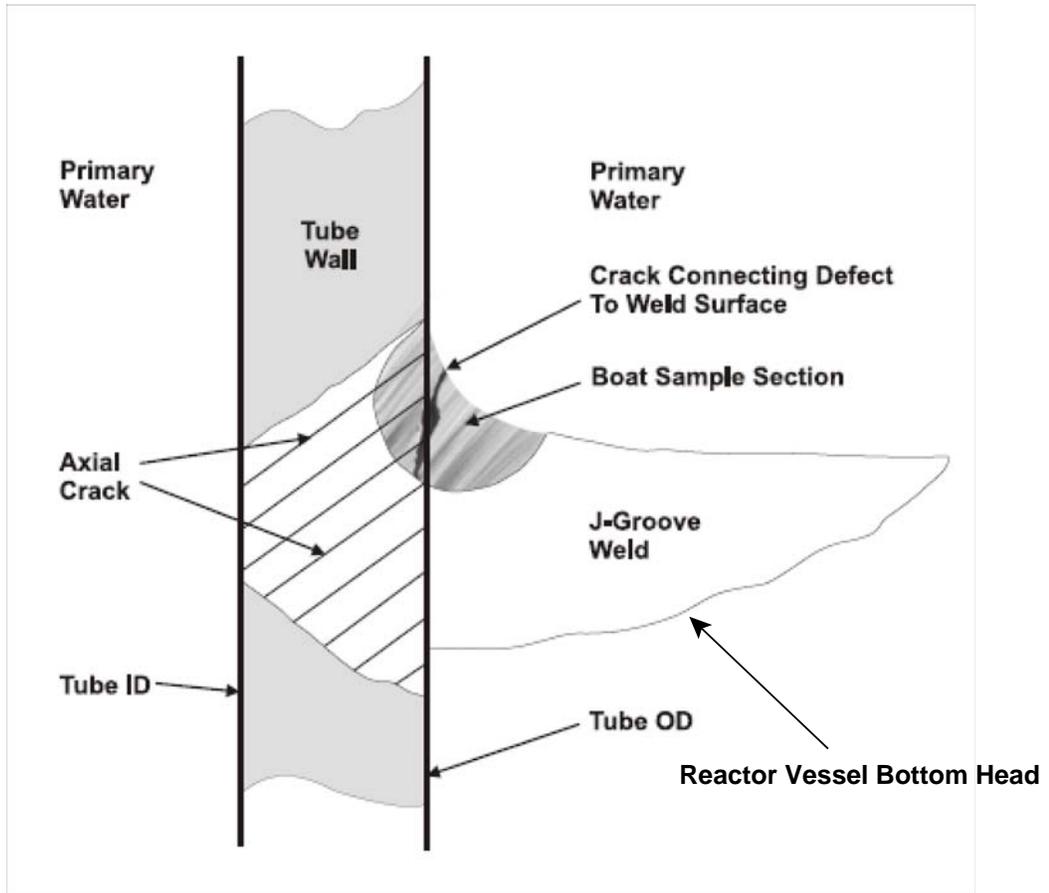
Figure 3-1 Composite Drawing Showing Axial Crack, Weld Flaw, and Weld Crack

To facilitate metallurgical analysis of the actual cracks, boat samples were removed from Penetrations 1 and 46 employing an Electric Discharge Machining (EDM) cutting technique. In the case of the BMI nozzles inside the reactor pressure vessel, the boat sample excavations could not be repaired. The desire for the largest possible boat sample was balanced against conservative structural limitations. The boat sample from Penetration 46 was designed to capture as much tube material as possible in an attempt to harvest a portion of a crack not connected to the ID of the nozzle. The margins for error associated with positioning the EDM equipment through 70 feet of water resulted in a shallow cut in Penetration 46. The resulting undersized sample was either inadvertently discarded or completely consumed in the margins of the EDM cutting tool. The boat sample from Penetration 1 captured material and defects from the J-groove weld and J-groove/tube interface, as designed. A composite drawing showing the axial crack, weld flaw and weld crack is shown in Figure 3-1.

The boat sample from Penetration 1 contained a portion of the large through-wall axial crack in the tube, three "discontinuities" which were confirmed to be lack of fusion resulting from slag inclusions, and one crack at the helium bubble location which connects the surface of the J-groove weld to the largest area of lack of fusion. The crack in the weld that connects the surface of the J-groove weld to the largest area of lack of fusion was determined from the inspections to be singular and unique. A 0.2-inch long crack spanned an 0.080-inch ligament separating the lack of fusion void from the surface of the J-groove weld in the ground fillet transition at the tube/J-groove weld interface. The length of the crack spanned and was limited to the width of the lack of fusion void. The section of the boat sample containing this crack was broken in the laboratory to expose the crack face for examination. Tenacious deposits obscured the crack face, and gradually more aggressive attempts to remove the deposits also attacked and distressed the metal surface. The crack exhibited some intergranular characteristics. To some reviewers, the nature of the oxide deposits suggested hot cracking. Fatigue could also be a factor in the development of this crack. However, the precise mechanism responsible for initiating and propagating this crack could not be determined.

Earlier ultrasonic testing (UT) results identified an axial crack in Penetration 1 which penetrated the inside diameter of the nozzle and extended from just above to just below the J-groove weld. The boat sample from Penetration 1 successfully captured a part of the upper portion of this crack in the region of the tube/J-groove weld interface. The intergranular nature of this crack

exhibited classic primary water stress corrosion cracking (PWSCC) characteristics. The extent of the crack was examined by progressively grinding away thin layers of the section of the boat sample. The orientation of the ground surface was such that more weld material and less tube material was exposed at each successive grind. The initial exposed surface consisting of nearly all tube material contained a crack that extended into the weld material and then stopped. As successive layers were ground away, exposing more weld and less tube, the extent of the crack became smaller and smaller. The final ground surface, which consisted almost entirely of weld material, revealed no crack at all in the weld and a small vestige of crack in the remaining small bit of tube.

The axial crack in the tube appeared to grow from the EDM surface out to the tube/J-groove interface since it branched and connected two of the three voids, at least at this location in the boat sample. This fact might suggest inside surface initiated PWSCC. However, neither of the two cracks in Penetration 46, the other leaking BMI penetration, connected to the inside surface of the tube. A supplemental eddy current examination of the inside surface was performed, specifically to confirm the UT results that the flaws did not penetrate the inside surface. Eddy current examination established that the cracks did not connect to the inside surface. Based on this fact the licensee concluded that the PWSCC axial crack in the tube was OD initiated. The crack most likely originated on the outside surface of the tube in the highly stressed region of the flooded weld defects.

The boat sample also contained numerous small cracks around the periphery of the tube containing lack of fusion (LOF) voids to a depth of 1 or 2 grains. Although hot cracking in the weld material is a possibility, this intergranular cracking also appeared in the nozzle, where hot cracking is not possible. Therefore, the licensee concluded that this cracking is PWSCC resulting from flooding of the LOF voids.

In summary, metallurgical analysis of a sample removed from one of the leaking BMI penetrations confirmed the presence of weld defects on the highly stressed interface between the Alloy 600 tube and the connection weld to the pressure vessel. The SMAW process used to construct the J-groove welds is prone to leaving weld defects in service and creating locally high residual stresses. The sample revealed one small crack that connected the LOF void to the surface of the weld and primary water. Once the LOF void became flooded with primary water, all of the requisite conditions to support stress corrosion cracking existed at the nozzle outside surface at a location of predicted high residual stress.
